Bangor Wharf

GROUND INVESTIGATION REPORT

Bangor Wharf
Georgiana Street
London NW1

J15227A

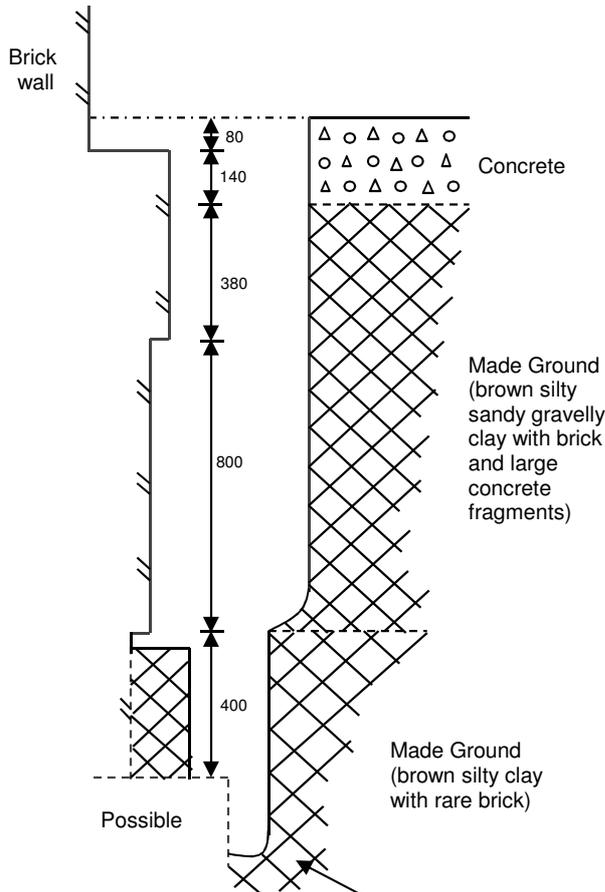
TP1 - SECTION A - A'

Trial pits deepened to 2.0 m with hand auger

Remarks:
All dimensions in millimetres
Trial pit sides remained stable during excavation
Groundwater not encountered

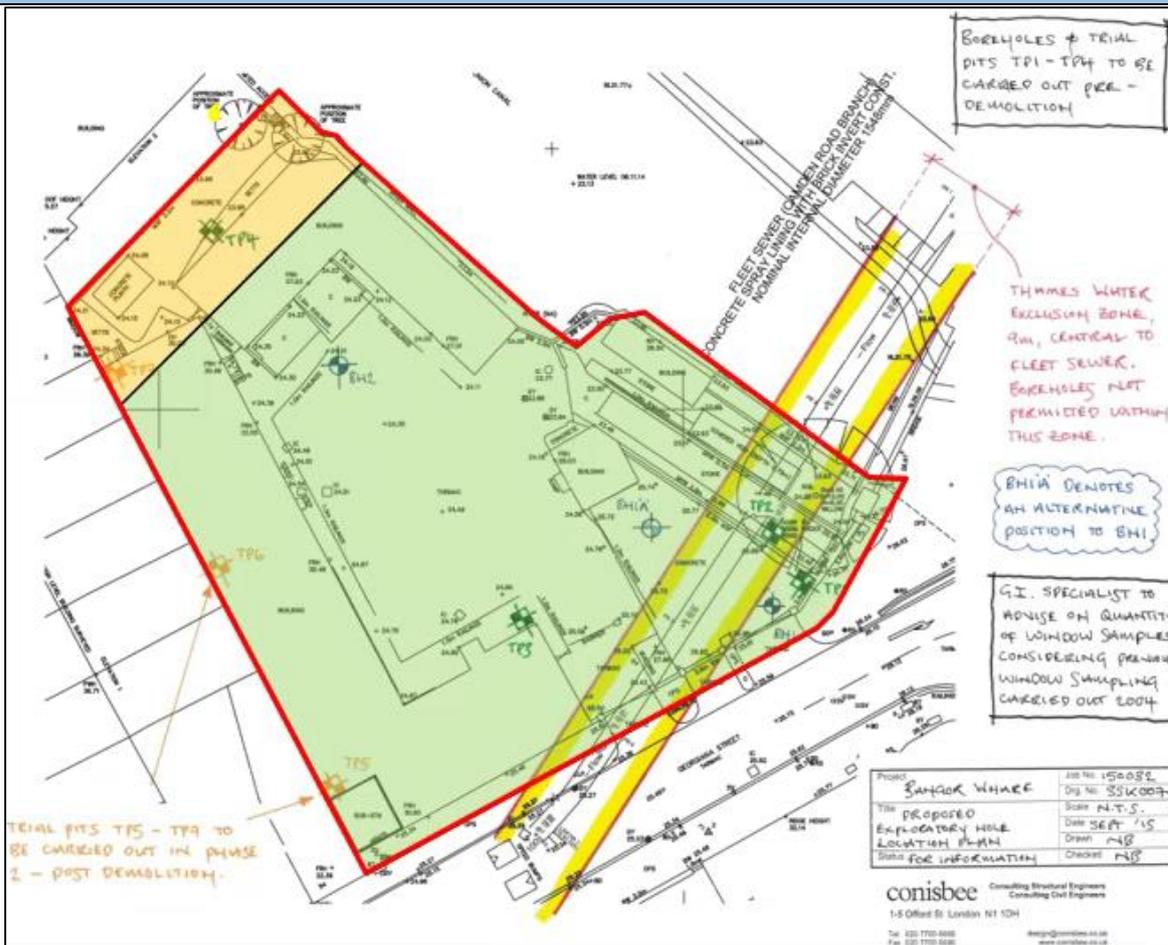
Risk Map

The majority of the site has been assessed as low risk, with only a relatively limited area on the north-western part of the site that has been assessed as medium risk. It is therefore recommended that all personnel working on the site attend a site specific UXO awareness briefing, which can be included as part of a site indication.

Additional mitigation measures will only be required in the medium risk area, which should include the presence of a UXO engineer to provide a watching brief and, where applicable, carry out a non-intrusive magnetometer survey of all shallow intrusive positions, such as trial pits, service trenches and shallow foundations. For all deep intrusive works within the medium risk area, such as piling, an intrusive magnetometer survey to the maximum predicted bomb penetration depth is recommended.
