The Interchange, Oval Road, London NW1 7DZ

FEATURES OF SIGNIFICANCE IN THE INTERCHANGE BASEMENT

Report to British Waterways

July 2010

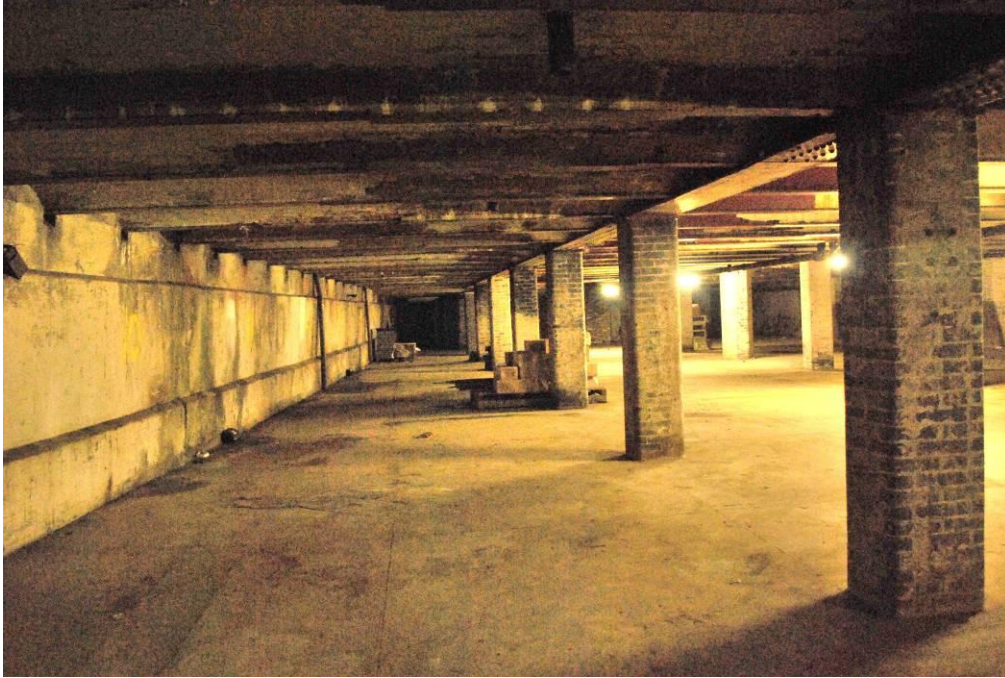
- 4.2 Structural Steelwork: The details of the structural steelwork described in 3.2 above are characteristic of the leading practice of the 1900s, when technical development and rising prosperity allowed the structural capabilities of steel to be exploited to the full and reinforced concrete had yet to establish itself fully as a competing material. The close spacing of heavy compound girders in the secondary spans, able to support

Fig 18 (above): View southwards at E side of Basement, with back of former retaining wall on left. Main beam (north-south) with brick-encased columns. Secondary beams (east-west) beneath former rail track.

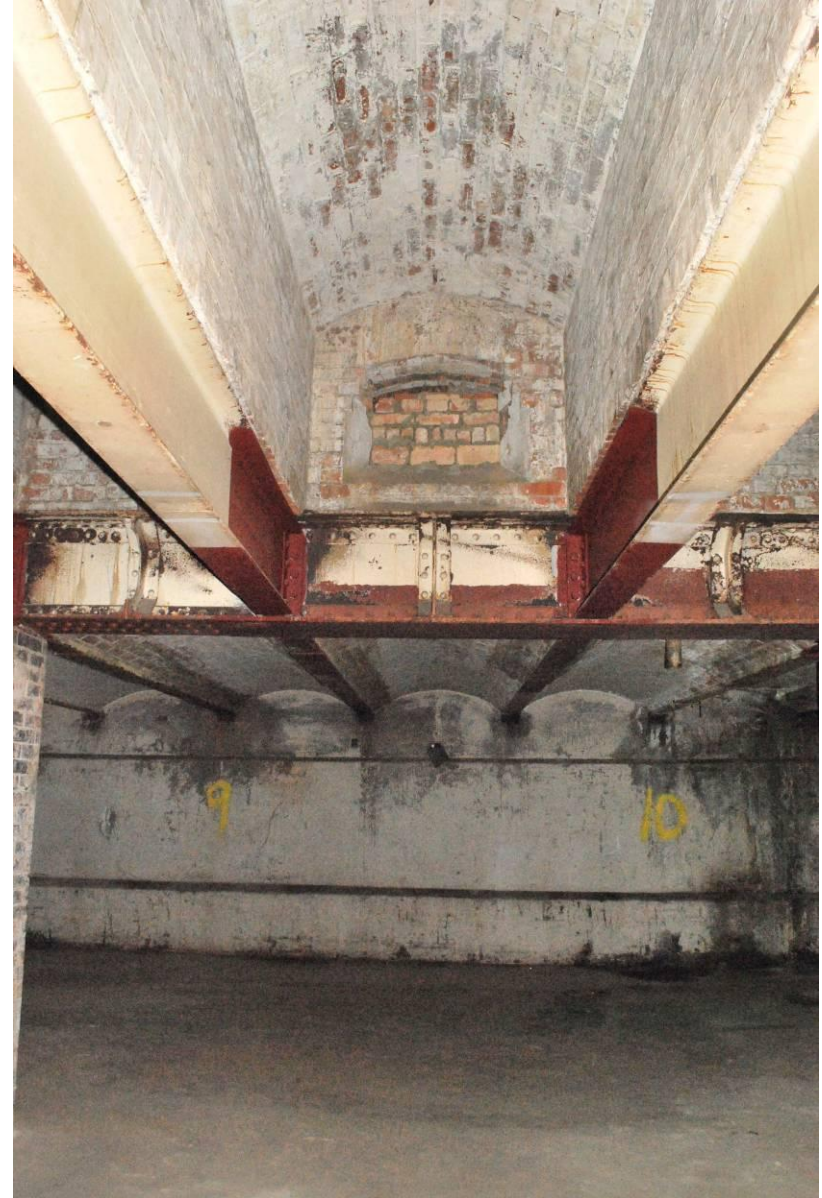
- 3.3 The beams in the basement ceiling are located below the level of the sidings, leaving dead space above them under the platforms. In those locations, the jack arches were built about 4ft 6in. (1.35m) higher, raised on brick sleeper walls above each of the secondary beams, which are at 4ft 10in. (1.47m) centres. In the sides of the platforms, below every third jack-arch, openings to ventilate the basement were provided, closed by wooden flaps. There are similar vents in the wall to the dock. (See figs. 19 to 21).

Fig. 19 (right): Main beam (north-south) of plate girder construction. Secondary beams (east-west) under platform area are rolled steel beams (supporting raised ceiling on brick sleeper walls). Secondary beams under rail tracks beyond are of rolled steel beams strengthened by riveted flange plates, i.e. compound girders.(See paragraph 3.2) Red oxide paint on areas corroded and repaired areas.

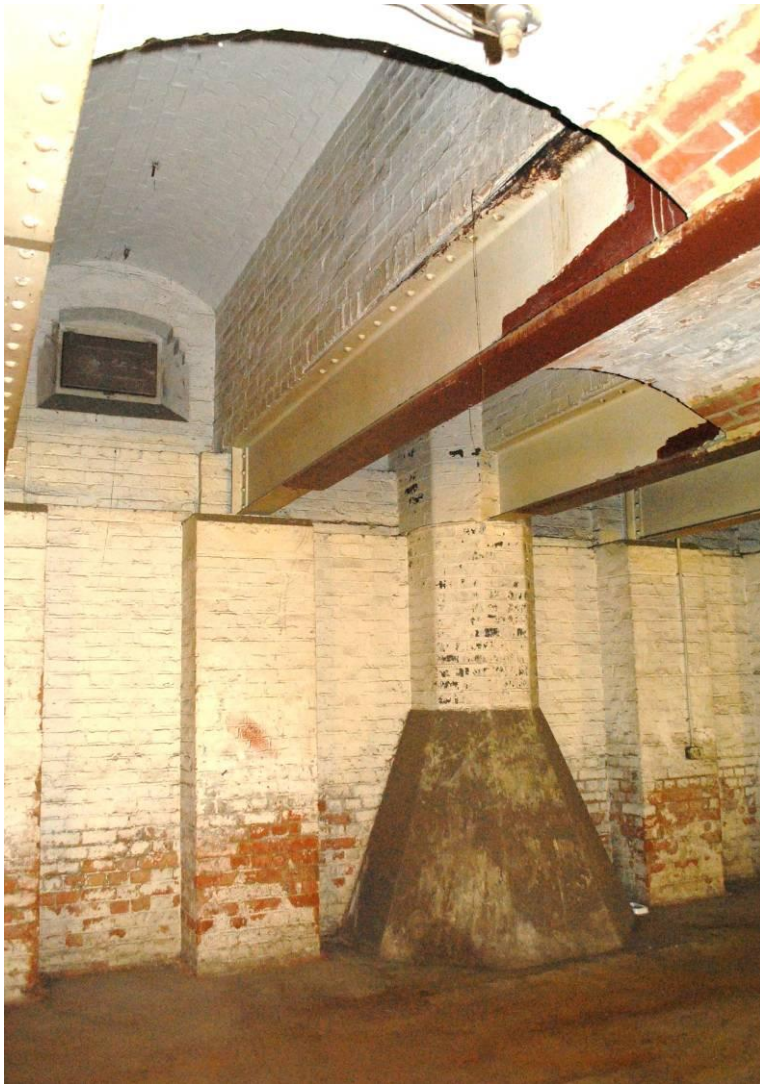
- 4.4 Ventilation Openings: The ventilation openings in the sides of the platforms and in the wall to the dock express the functional need for ventilation of the basement, situated next to a dank canal. Although many have been bricked up, presumably for modern fire separation, some of them remain with their hinged wooden flaps and iron gratings on the outside. They add visual interest to the raised ceilings.

Fig. 20: Dividing wall between Basement and Dock, with flared column base and ventilation shutter. View from SE.

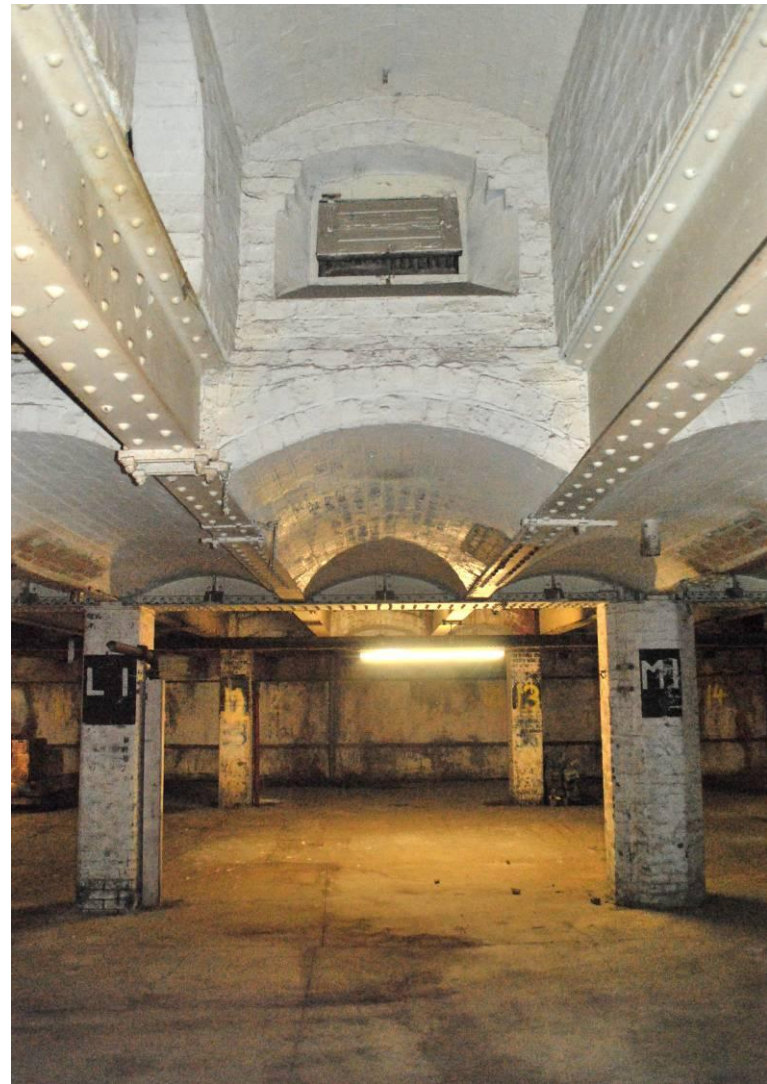
- 4.3 Raised Ceilings under Platforms: The raised areas of ceiling are important in expressing the presence of the former railway platforms, an essential feature of the building, since they have been covered over and obscured from view as seen from above.

Fig. 21 Raised ceiling on sleeper walls under a platform, with ventilation shutter in platform side. View from W.

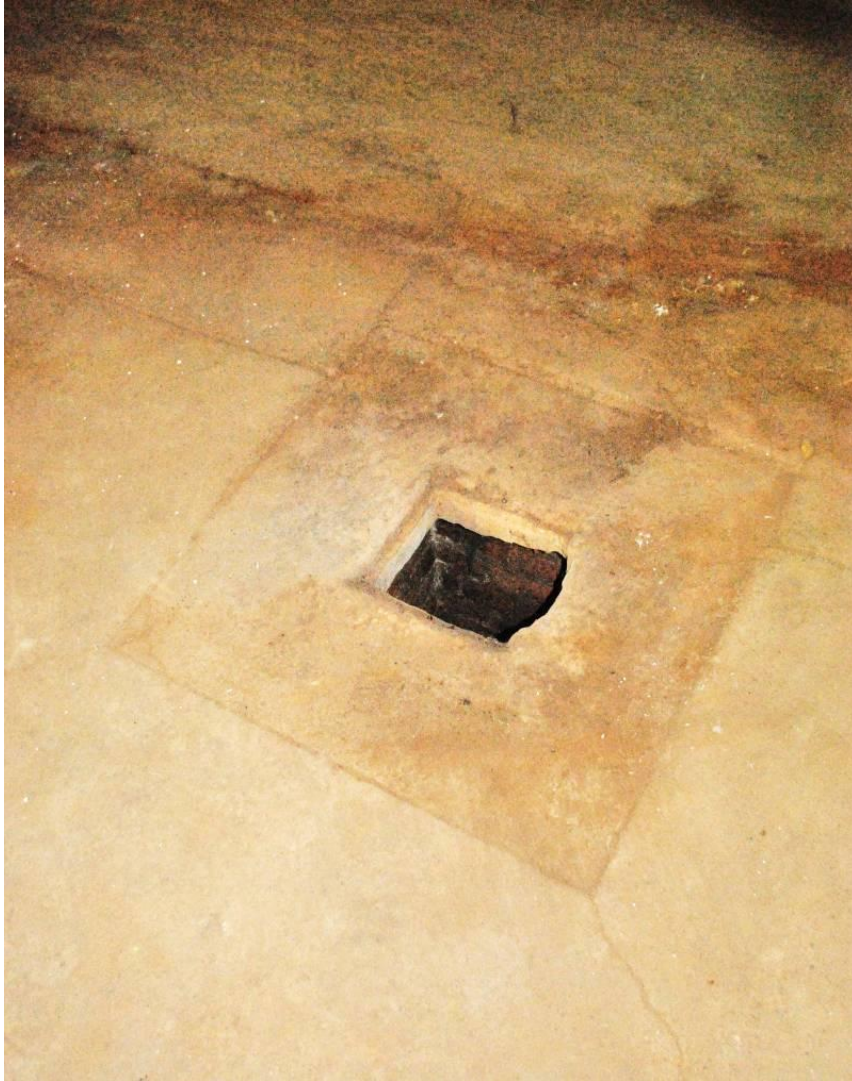
- 4.13 Floor Drains: The basement floor of concrete slabs neatly divided into panels may possibly be the original "9 inch lime concrete". Set into the floor, at the centres of substantial York Stone paving slabs, are four drainage gulleys, as a precaution against liquid spillages or leakages. They discharge into the basin. The gully gratings are missing but otherwise they appear to be in pristine order. (See fig. 22).

Fig. 22 (left): Drainage gully in floor

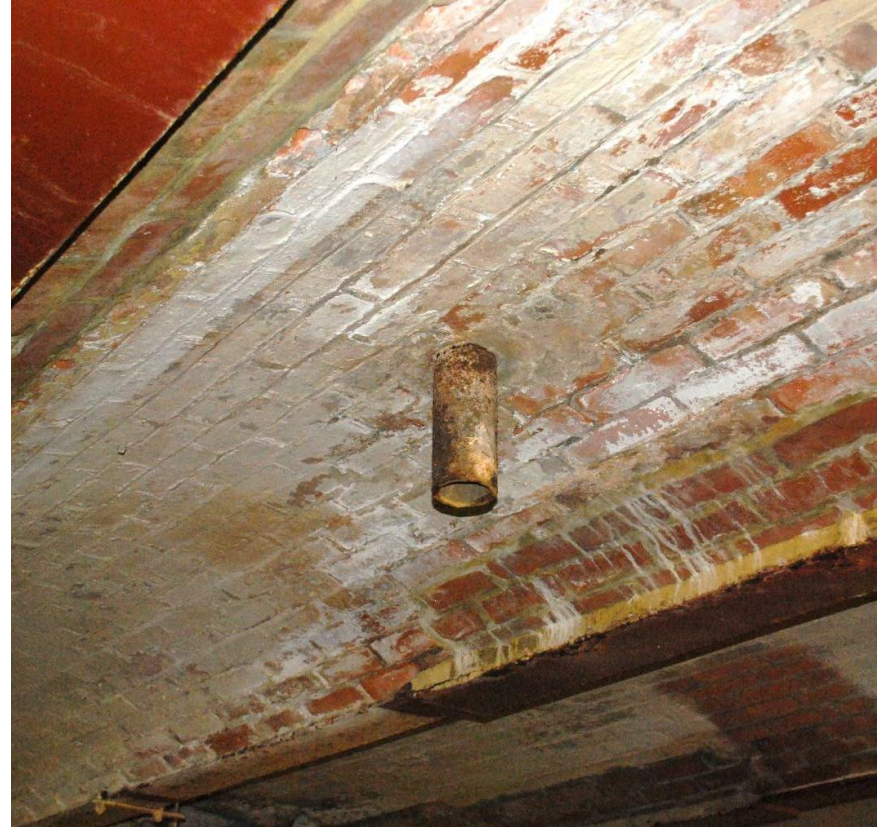
- 3.5 The rail sidings were originally paved with blue brick paving and the jack arches beneath them were to be set in cement rather than lime mortar, which would provide frost resistance.²⁶ Cast-iron drain pipes, now seen protruding through the ceiling and disconnected below, will have served gulleys for rain water that made its way in from beyond the end of the glazed canopy or dripped from wagons. (See fig. 23).

Fig 23 (right): Drainage pipe from former rail siding above. Connecting pipework now removed.

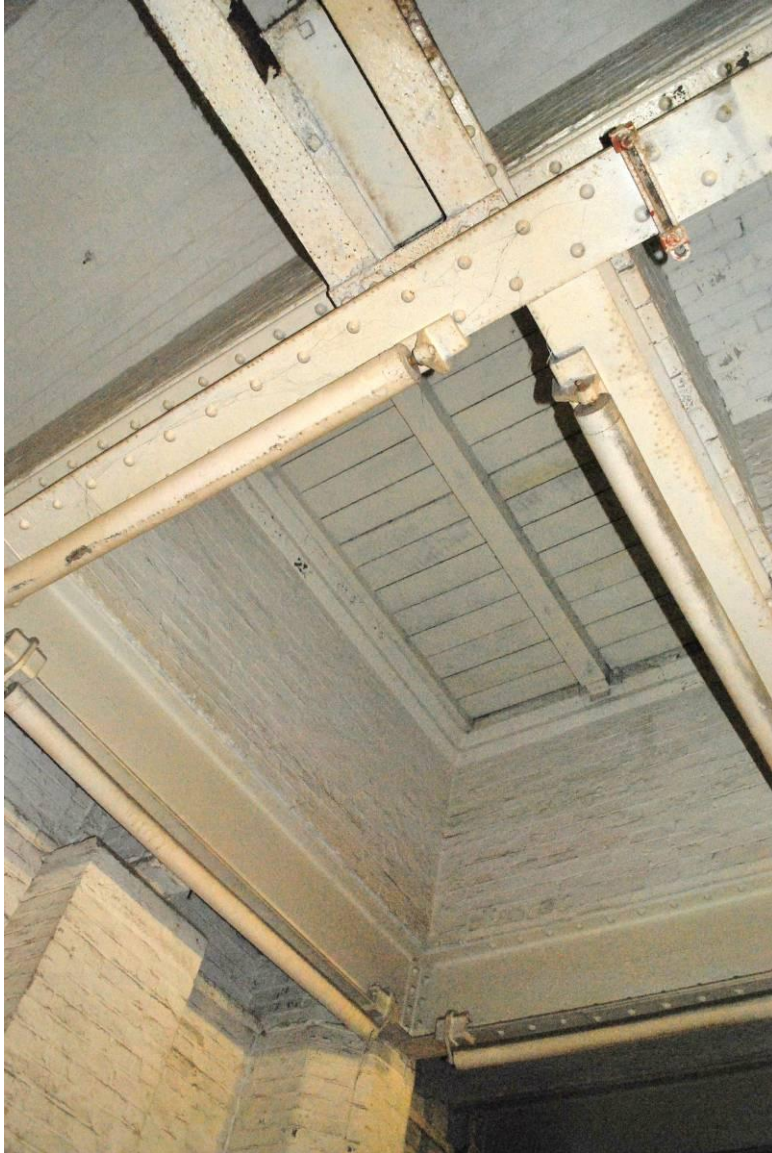
- 4.10 Trap Doors: Trap door openings in the basement ceiling were seen to remain at C/D-7 and 11, and they should remain similarly over the dock at D/E-6 and 14 and E/F-14. The openings are substantial, about 2½ metres by 2 metres, requiring structural trimmer beams to support the interrupted secondary beams. Brick-lined wells penetrate the platform void space above the basement. There are beech-wood rollers in cast-iron bearings around the lower edges to prevent rope wear. The trap doors themselves differ from the design shown on the 1901 drawings²⁹ – there appear to be two heavy wooden panels probably lifted by crane and resting on a removable joist along the centreline.

Fig. 24 (left): Trap Door in platform above basement, with brick well though the ceiling void and trimmer beams below. At D-11 from SE.

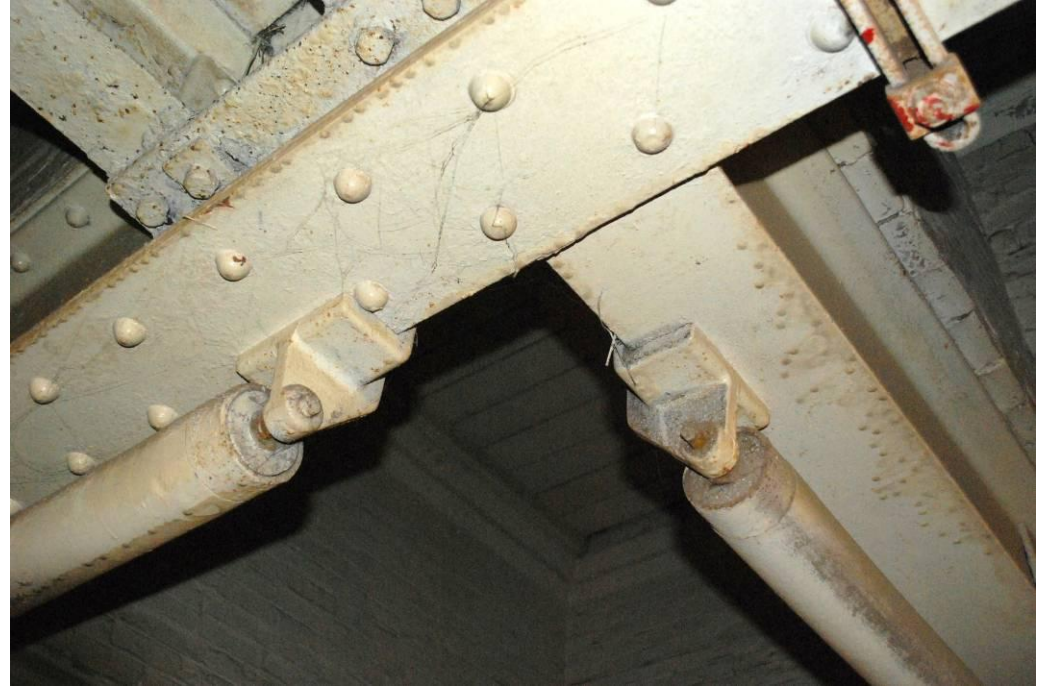
Fig 25 (above): Detail of rollers below trap door to protect against wear from ropes.

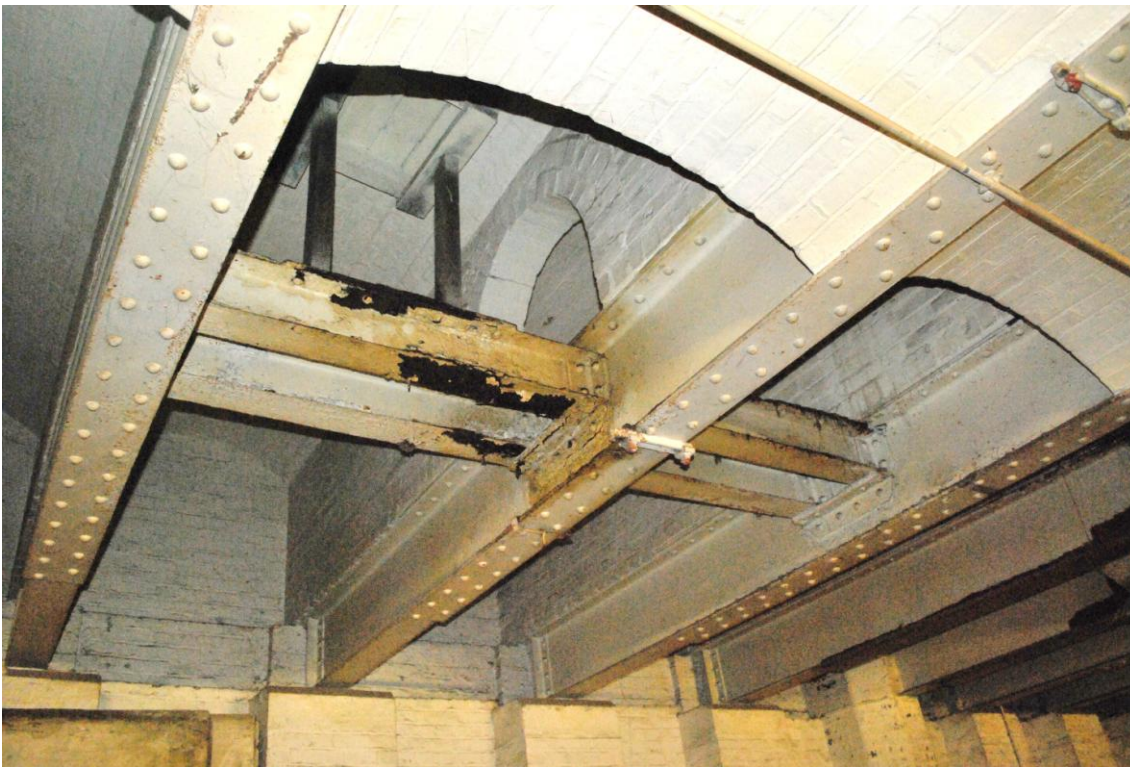
- 4.5.1 East of gridline C and between gridlines C and D, the upper pivots of the cranes were fixed to the beams at first floor – a bracket for one crane projects from the east wall of the warehouse at C-5 at that level. At these locations, therefore, the basement ceiling mountings provided only vertical support. They are identified by pairs of substantial steel joists bridging between the secondary beams to carry the footstep bearings and slewing gear. In most cases, a steel spreader plate on top of one span of the joists and a small square hole at the centre of the jack arch above it indicate the position of the crane post, matching the locations shown on the 1902 ground floor plan to within a foot. Slewing cylinders were also mounted here, with their rams extending through an arched opening in the adjoining sleeper wall, while a further span of joists beyond the sleeper wall supported hydraulic control gear. (See Fig. 25).. One set of this equipment survives and is described in 4.6 below.

Fig. 25 (above): Twin beams to support platform crane, seen here at C/D-10. Note small square hole for foot of crane post and archway for slewing rams. View from SE. Compare Figs. 31-2.

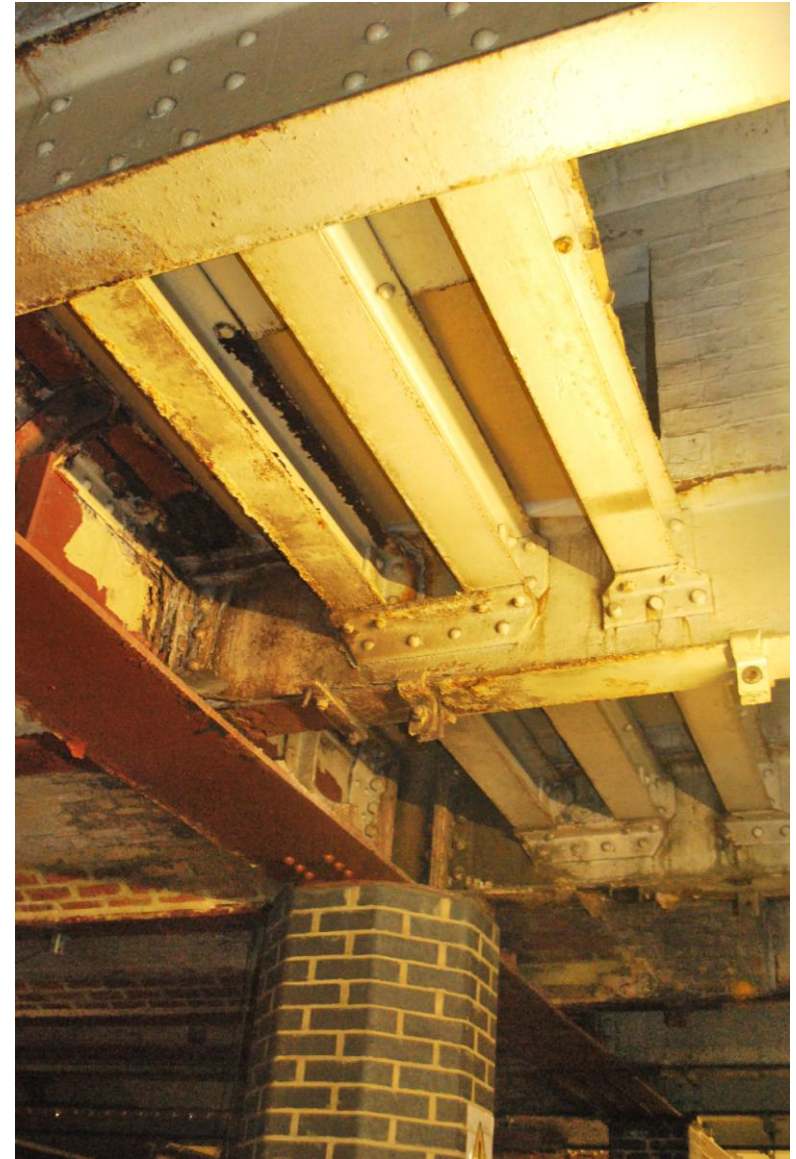
- 4.5.2 At C-9 the support is a variant of that above, with a third joist in parallel and a larger sleeper-wall opening. The crane post may have been located differently. (See Fig. 26).

Fig. 26 (right): Variant design with three beams next to C-9, view from SE.

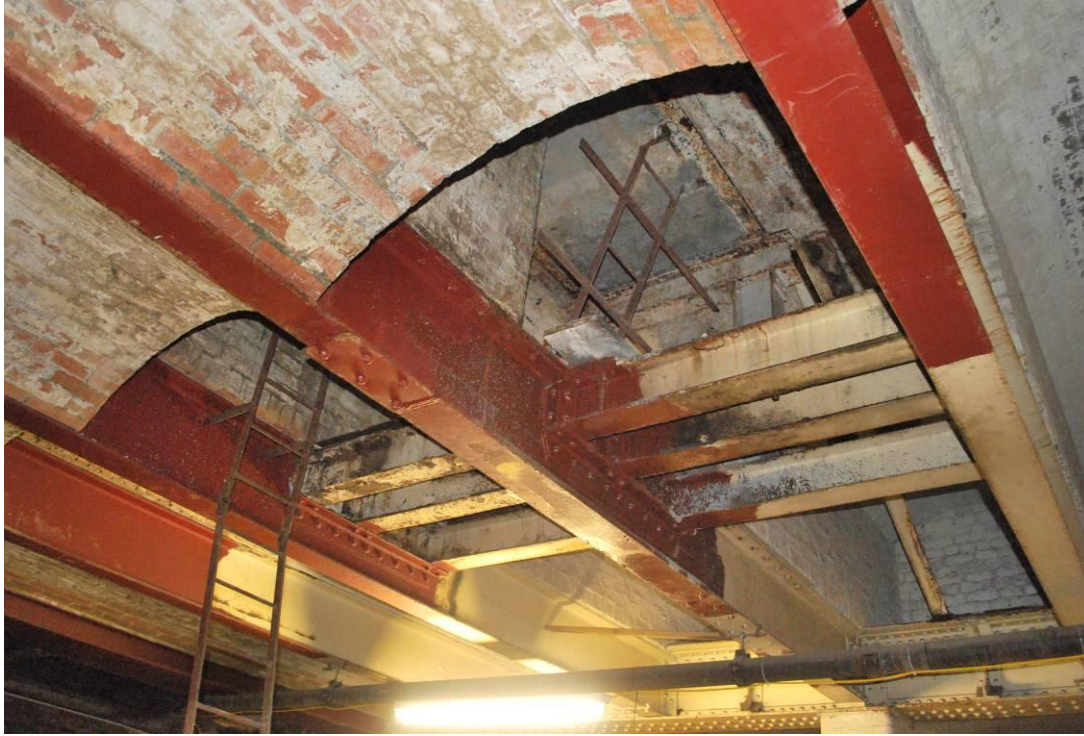
- 4.5.3 Adjoining gridline B, the cranes under the glazed roof may have been freestanding, requiring their upper lateral support to be at platform level (to stop them falling over), although it was common to fix lateral bracing between the roof trusses in such a situation. In any event, they seem to have been of a different design from the others, although all were to be of the same 15cwt capacity in 1902. A large hatch, now sealed with concrete, was provided through the platform deck, which will have allowed the whole crane post to pass through. This hatch interrupted the pair of jack arches, necessitating trimmer joists, whose outer ends are each propped by a steel post off an additional joist that lies parallel to the others at the lower level. The upstanding frame thus created is braced by inclined struts back to the girders

Fig. 27 (above): More elaborate mounting for platform crane at B/C-14 with third beam, viewed from NE.

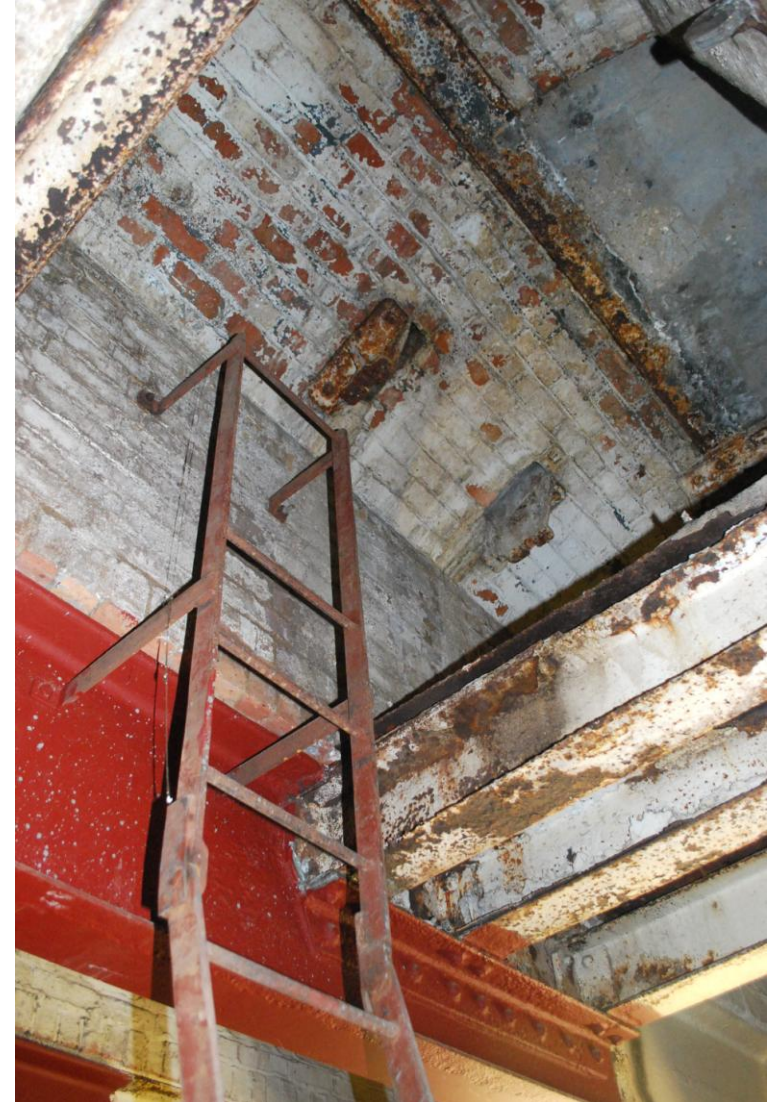
- 4.7 Pairs of holes for the control rods or cables can be seen at the other crane mounting locations (see 4.5.1 and 4.5.2). At B/C-14, bearings for the bell cranks remain, but of a different design from C/D-14, and there are also small pulleys for further control cables. (See figs. 28, 29).

Fig. 28 (right): View from NE at B/C-14 looking up into the ceiling space, showing fixings for hydraulic control gear next to holes for control rods. Former large opening to above for crane post to pass through is seen top right, infilled with concrete.

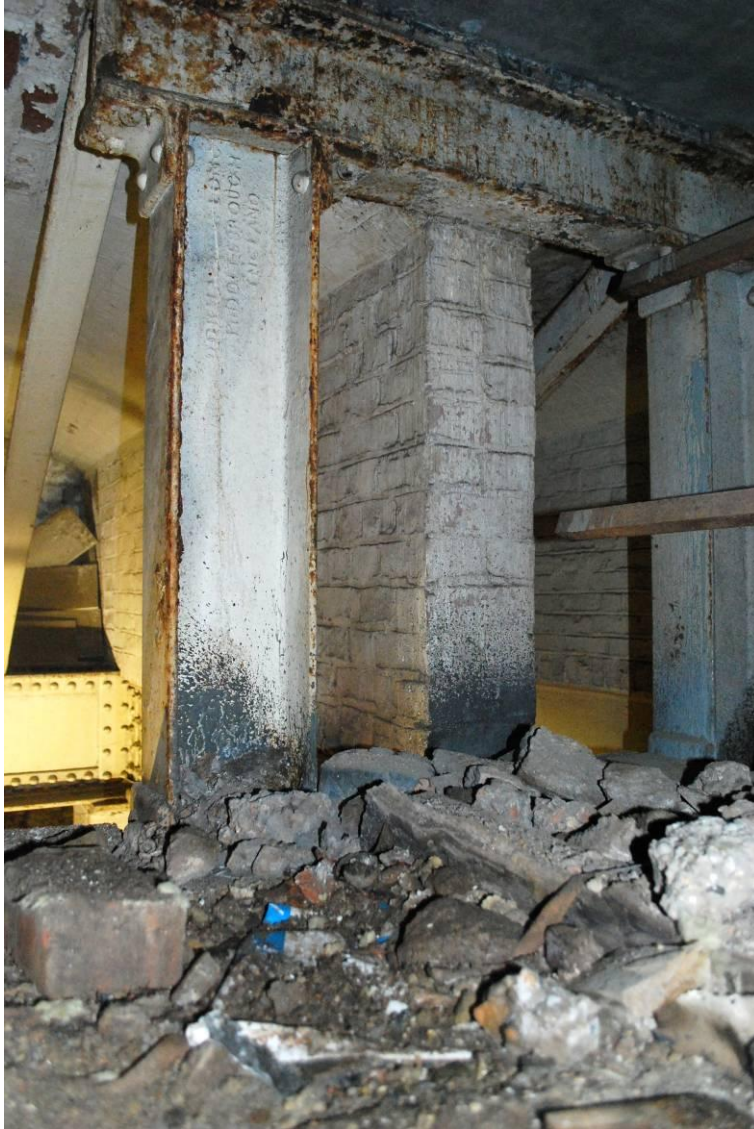
at the lower level, to give lateral stiffness to the platform in its narrow, east-west direction. The provision of this bracing is consistent with the cranes having been freestanding. There are further arches through the sleeper walls, presumably to accommodate the hydraulic equipment. At B/C-14, a folding access ladder and an upper ladder to platform level remain in place, possibly later insertions. (See figs. 27 to 30).

Fig. 30 (left): View from SE within ceiling space at B/C-14, showing posts and joist forming a frame, which supports the trimmer joists and is braced back to the beams at lower level seen on the left to give lateral stability to the platform.

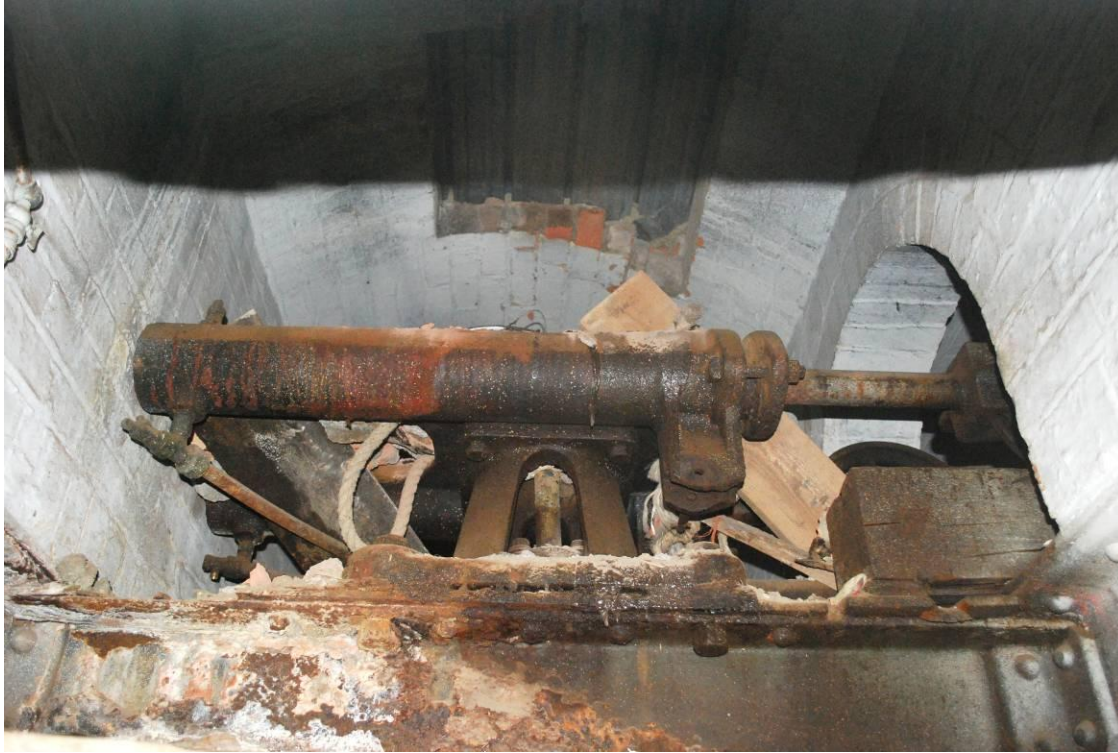
- 4.6 Hydraulic Crane Slewing Gear: A remarkable discovery is the relatively intact remains of the hydraulic slewing gear for the crane at C/D-14, and the associated footstep bearing, mounted above the pair of beams described in 4.5.1. Small hydraulic cylinders are placed to either side of the bottom bearing for the crane post, with their rams projecting through an arch in the sleeper wall. Pulleys on the further ends of the rams will have engaged with chains to pull the crane post to left or right and thus turn the crane. Under the further jack arch there is the valve gear for operating both the slewing rams and the hoisting ram. (The hoisting ram was mounted on the post of the crane, as may be seen in the retained example within the offices on the ground floor). There are two rectangular holes in the ceiling for former rods or cables from control levers at platform level. Cast-iron bearing brackets are bolted to the brickwork next to the holes, to hold an axle for the bell cranks. (See figs. 31 to 34).

Fig. 31 (above): Slewing cylinder mounted on bottom support for crane, remaining in situ at C/D-14, viewed from east. Compare Fig. 25.

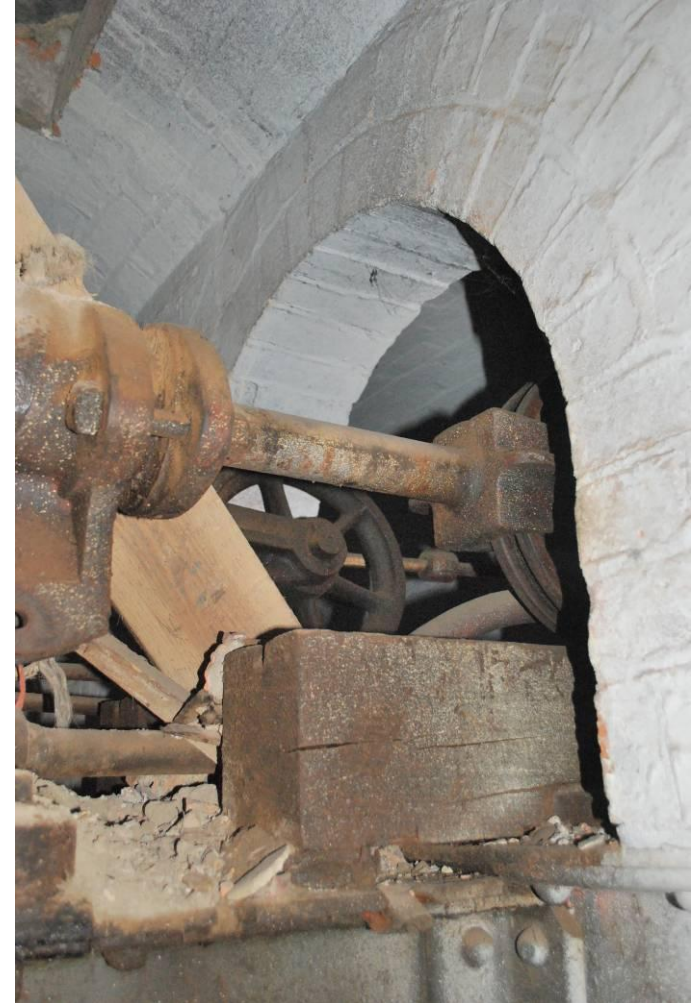
Fig. 32 (right): Slewing rams extending through the archway, viewed from SE.

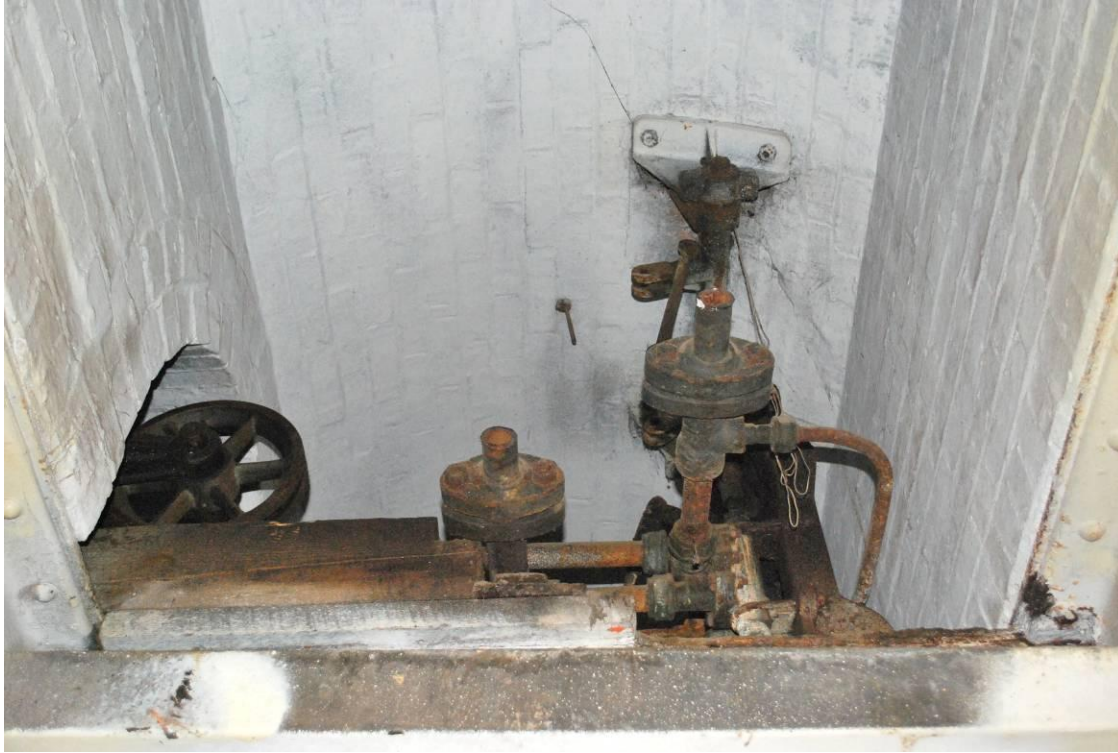
Fig. 33 (above): View of next ceiling bay, showing pulley on slewing ram protruding through archway, and control gear on right. Note hydraulic pipework, severed at front. View from east.

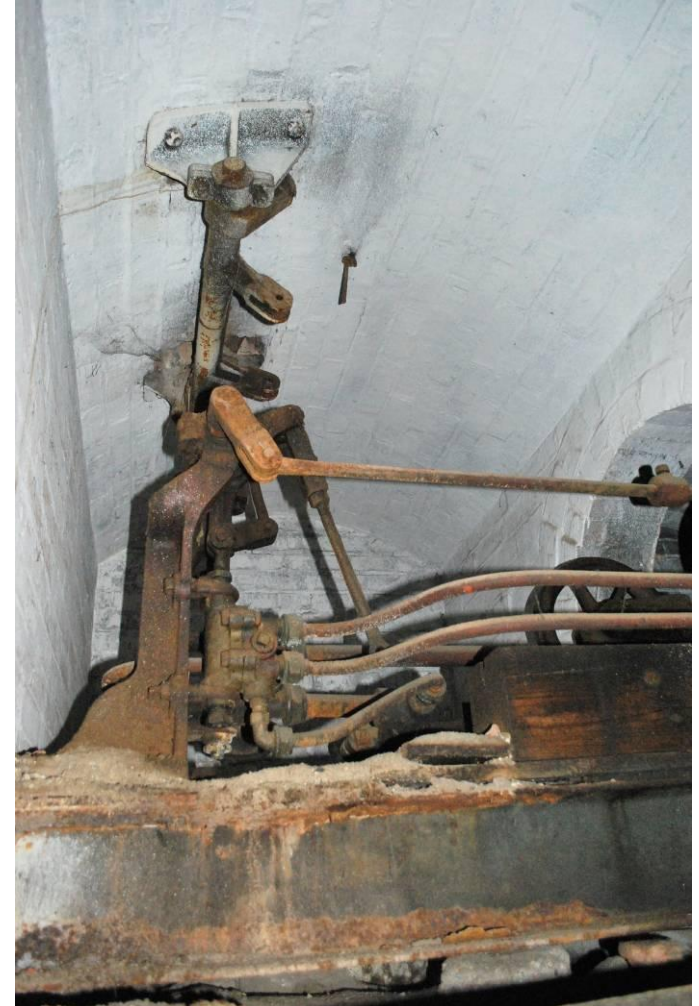
Fig. 34 (right): View of control gear from west. Note fixing brackets on ceiling, which are next to two holes for control rods or cables.

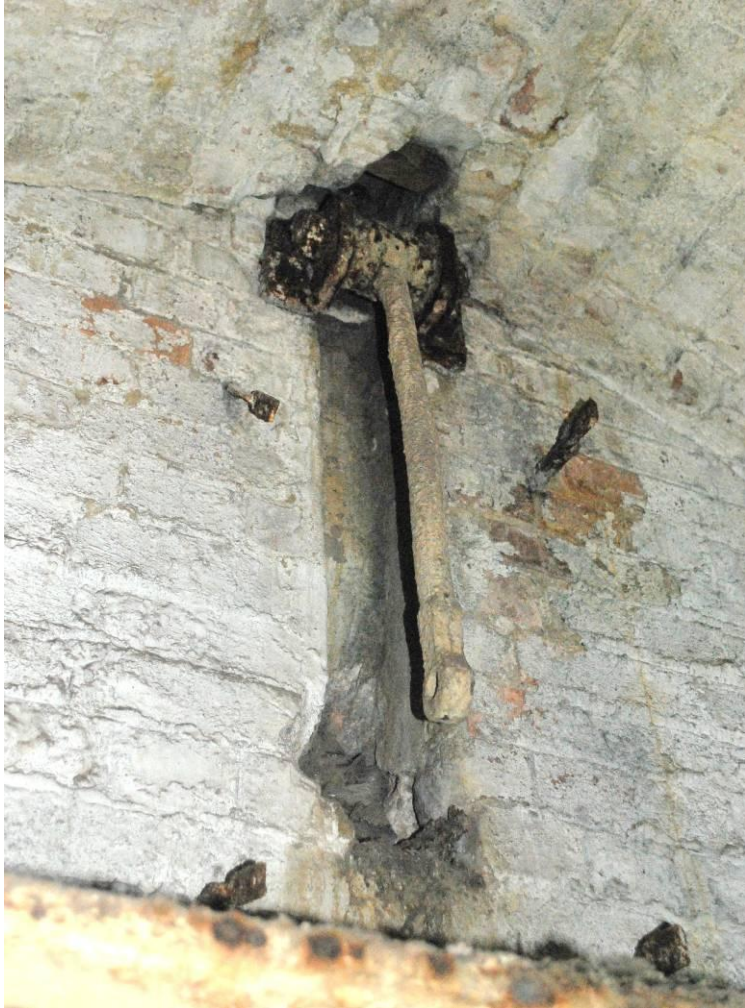
- 4.9 Evidence of Control Rods, Trucking Bridges and Wagon Stops: Near the middle of the western wall of the eastern platform, at grid reference C-8¼, there is a forged iron bar hanging from a pivot below the ceiling, next to a chase and small hole in the wall. It is evidently the **support for a control rod** that passed through the wall close to track level, either for the operation or control of one of the removable **trucking bridges** that joined the two platforms close to this point, or as part of a **wagon stop** mechanism, both of which are shown indicatively on an LMS drawing of 1923.²⁸ In the latter case, the sliding rod passing through the hole and worked by a lever at platform level would have placed a stop across one of the rails, to prevent a wagon from rolling into the bridge. The drawing shows that there were five such wagon stops in this vicinity. Further evidence of the bridges and wagon stops is likely to be found in a more detailed inspection. (See Figs, 15a, 15b and 35).

Fig. 35: Hanger bar for support of a control rod that passed through hole in platform wall behind. (See paragraph 4.4).

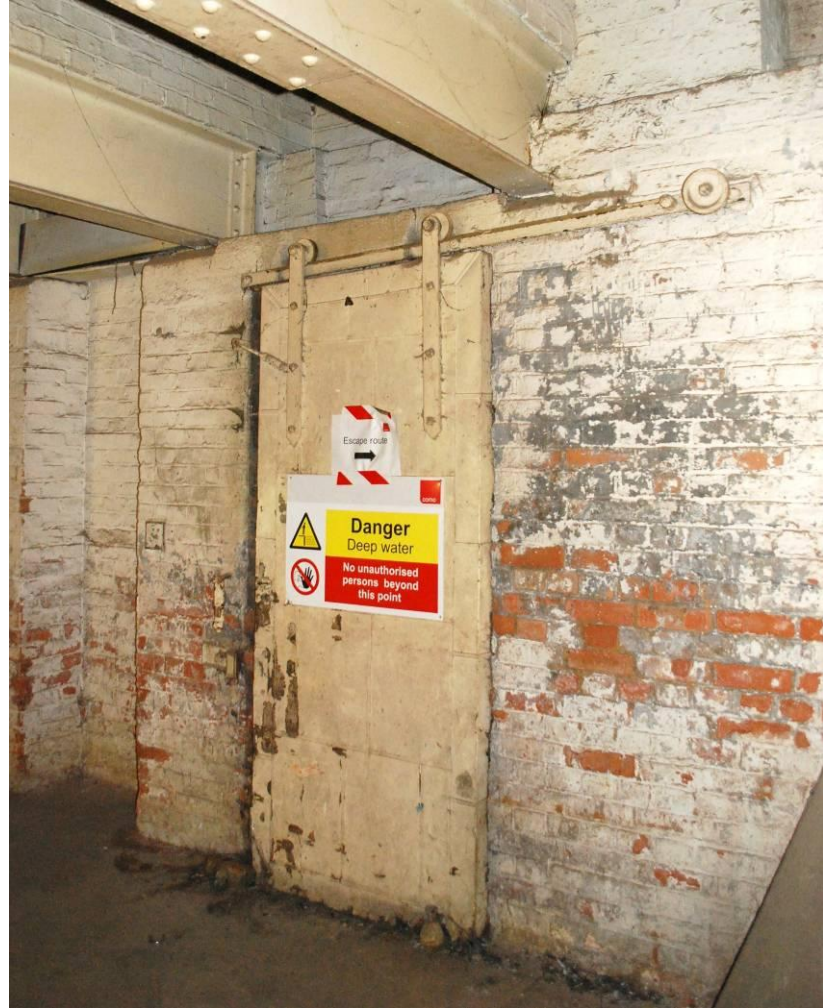
- 4.11 Sliding Fire Doors: Along the east side of the dock there are three narrow doorways for access to the waterside. A sliding door remains in place at two of them, being smaller versions of the fire doors shown on a 1902 drawing and described in 3.1 above.³⁰ These two are made of solid timber with sheet metal cladding. The counterweights with fusible link are missing, so they remain shut, although the pulleys for them remain mounted on the inclined runways. (See fig. 36).

Fig. 36: Sliding Fire Door to Dock at D-13/14

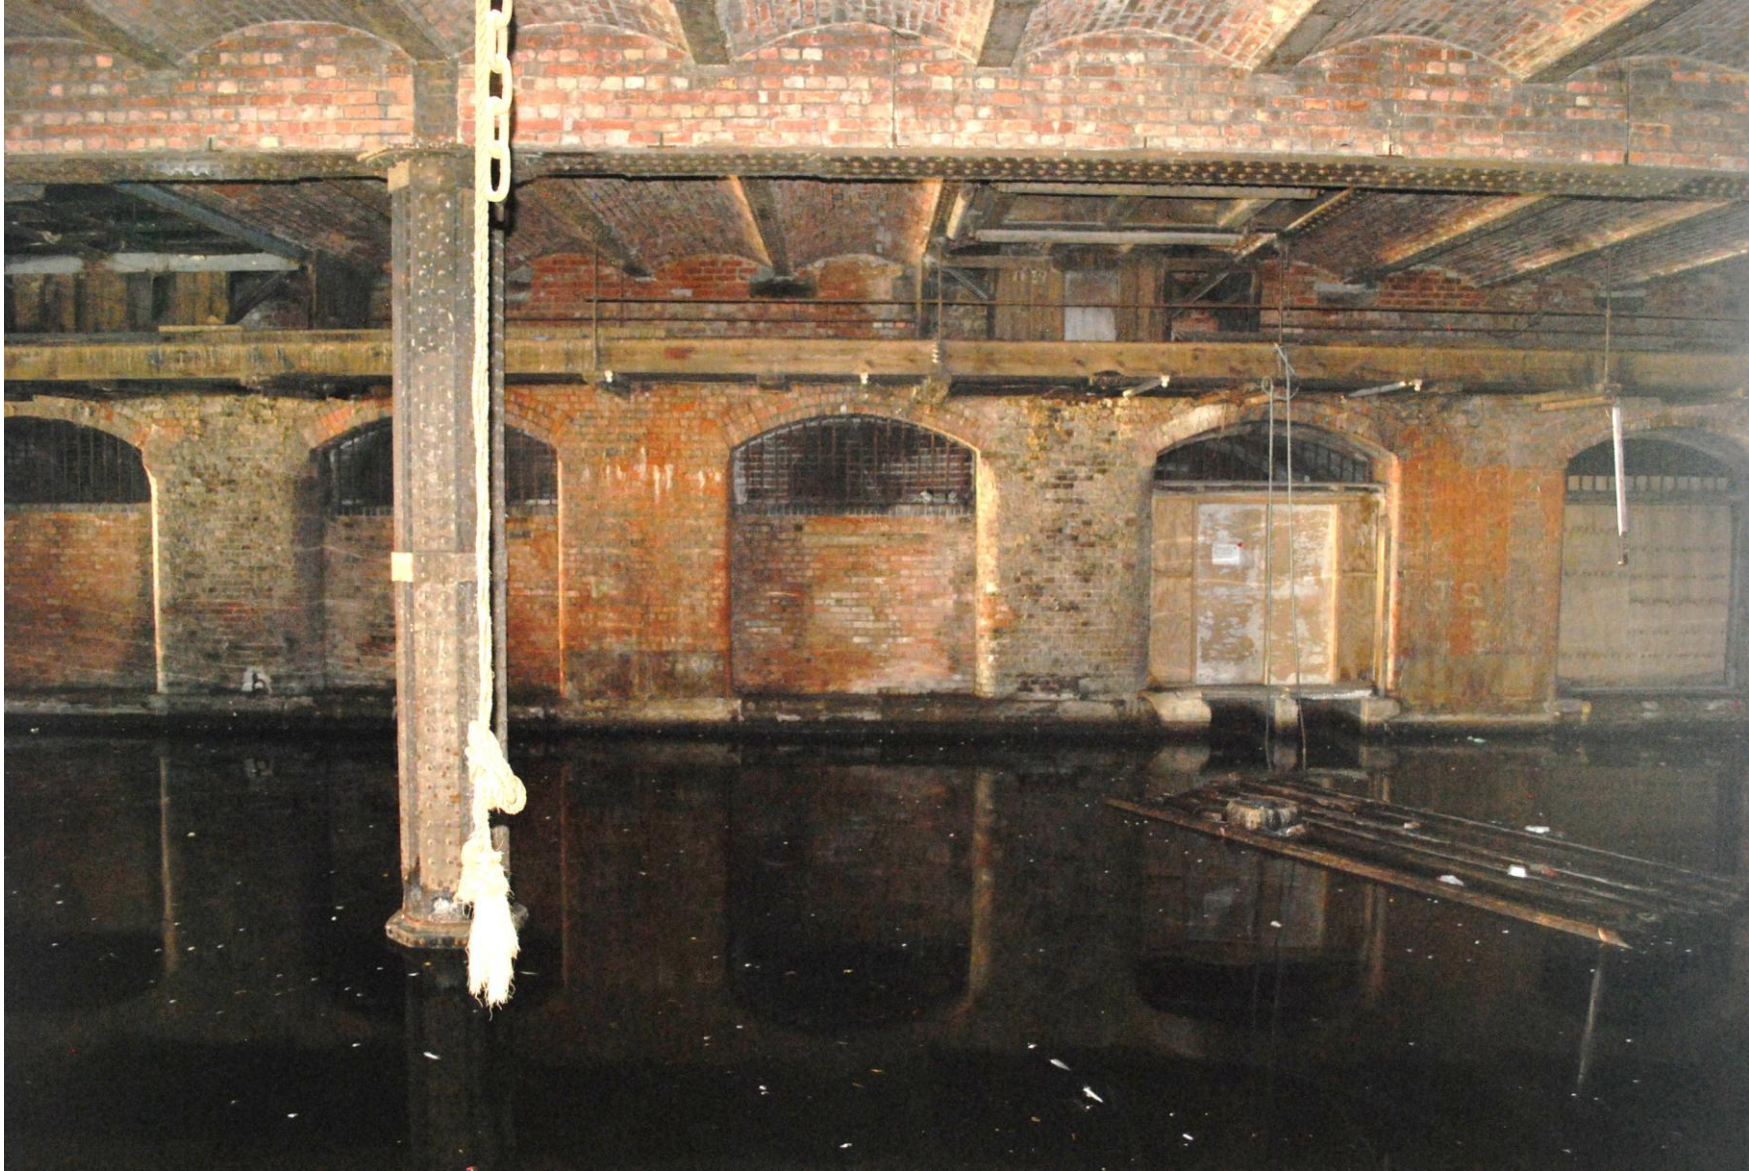
- 4.14 The Dock: About 225 feet (69 metres) long and 44 feet (13.4 metres) wide, this was wide enough for three barges when originally built in 1856, i.e. one moored on each side with an access lane down the middle. There was never room for a barge to turn round, so strictly a dock and not a "basin", although often so called. Insertion of the central line of columns will have marginally reduced flexibility of use, but it was probably never used intensively. In addition to the three hatches in the ceiling, there were two loading doors to the vaults near the northwest corner, but only three narrow doorways into the warehouse basement, perhaps provided with an eye to further storage in bond. There is a tradition that Gilbey's gave up water transport because of pilfering. The recent name of "Dead Dogs Basin" reflects its present abandoned state. (See figs. 17, 37, 38).

Fig. 37: View westwards across Dock from D-6/7.

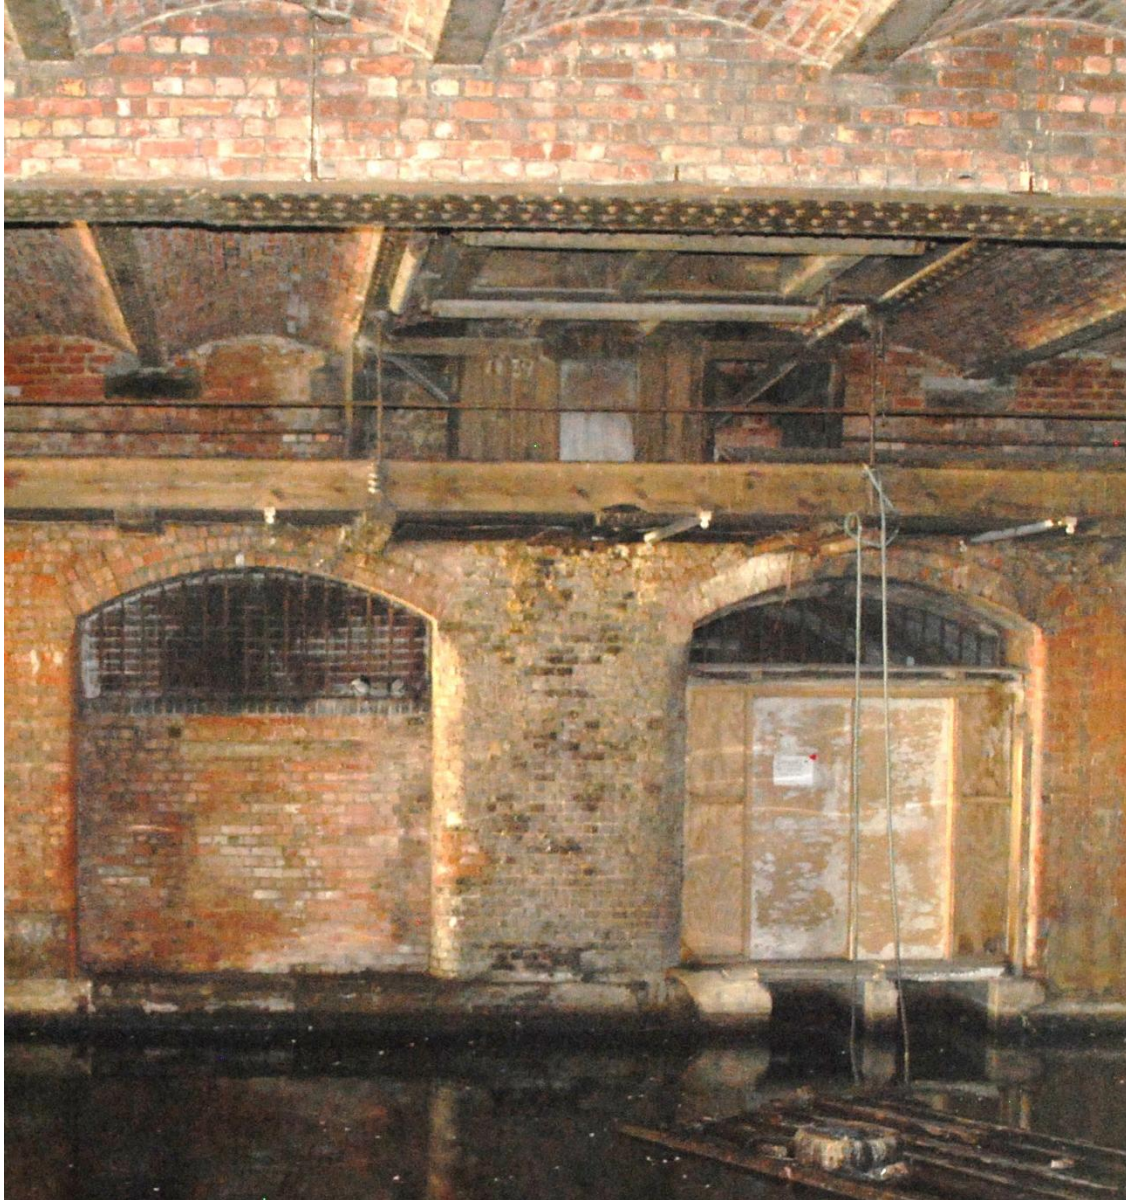
- 4.8 Catwalk and Slewing Gear over Dock: Over the dock, there is a timber catwalk or rather crawlway, suspended by rods beneath the ceiling close to line F. It is likely to extend the whole length of the dock, to give access to crane slewing gear. Because of inaccessibility for their removal, the several sets of slewing gear are likely to survive in situ here, although obscured by timber casings (for frost protection) when viewed from across the dock. (See fig. 38).

Fig. 38: Ceiling over Dock at E/F-6, showing trap door and suspended mounting for a platform crane, with north-south crawl-way for access.
