6 Arboricultural Impact Assessment

Project Camden Lock Market					
Client Castlehaven Row Limited					
Date 14.08.15		Scale 1:200 at A1 1:400 at A3			
Drawing Title Proposed Ground Floor Hard Landscape Plan					
Drawn AB		Checked RNH		Approved PJJ	
Drawing Status For Information					
Project 13483	Disc A	Level L00	Series P91	Dwg No. 100	Rev -

Project
Camden Lock Market

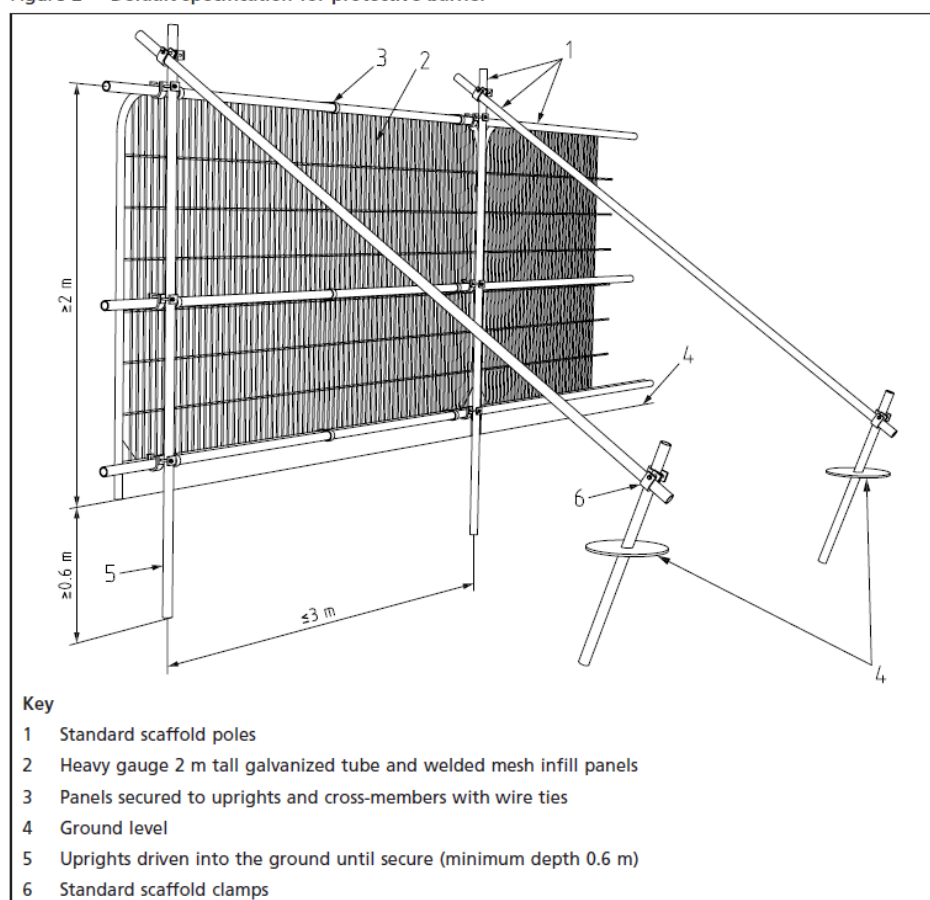
Figure 2 Default specification for protective barrier

Fencing in areas of high construction activity (as indicated on the Tree Protection Plans - Appendix C) shall be constructed with robust vertical and horizontal scaffold framework with weldmesh panels firmly attached as per BS5837: 2012 Figure 2 (included below). Vertical support poles must be located with care to avoid underground utility services and bracing poles must be sited to avoid the structural roots of retained trees. Where fencing must be erected on areas of existing hard surfacing stabiliser struts must be attached to the ground using ground pins. Where this would cause unacceptable damage to surfacing or is restricted due to the presence of services, struts will be mounted in block trays.

The existing permanent barrier fence adjacent to T1 along with the existing hard surfacing is likely to provide sufficient protection to this tree throughout the development works. Pedestrian access is also likely to need to be maintained due to the public footway. If the hard surface is to be removed this must be achieved as set out in Section 6.2.2. T2, T4 and T5 will require protective fencing as set out in the Tree Protection Plan (Appendix C).

The area inside this fencing is to be sacrosanct and once installed, barriers and any temporary ground protection must not be removed or altered without the prior approval of the site arboriculturist and where appropriate the Local Authority Tree Officer. Any damage to tree protection measures must be reported immediately to the site arboriculturist.

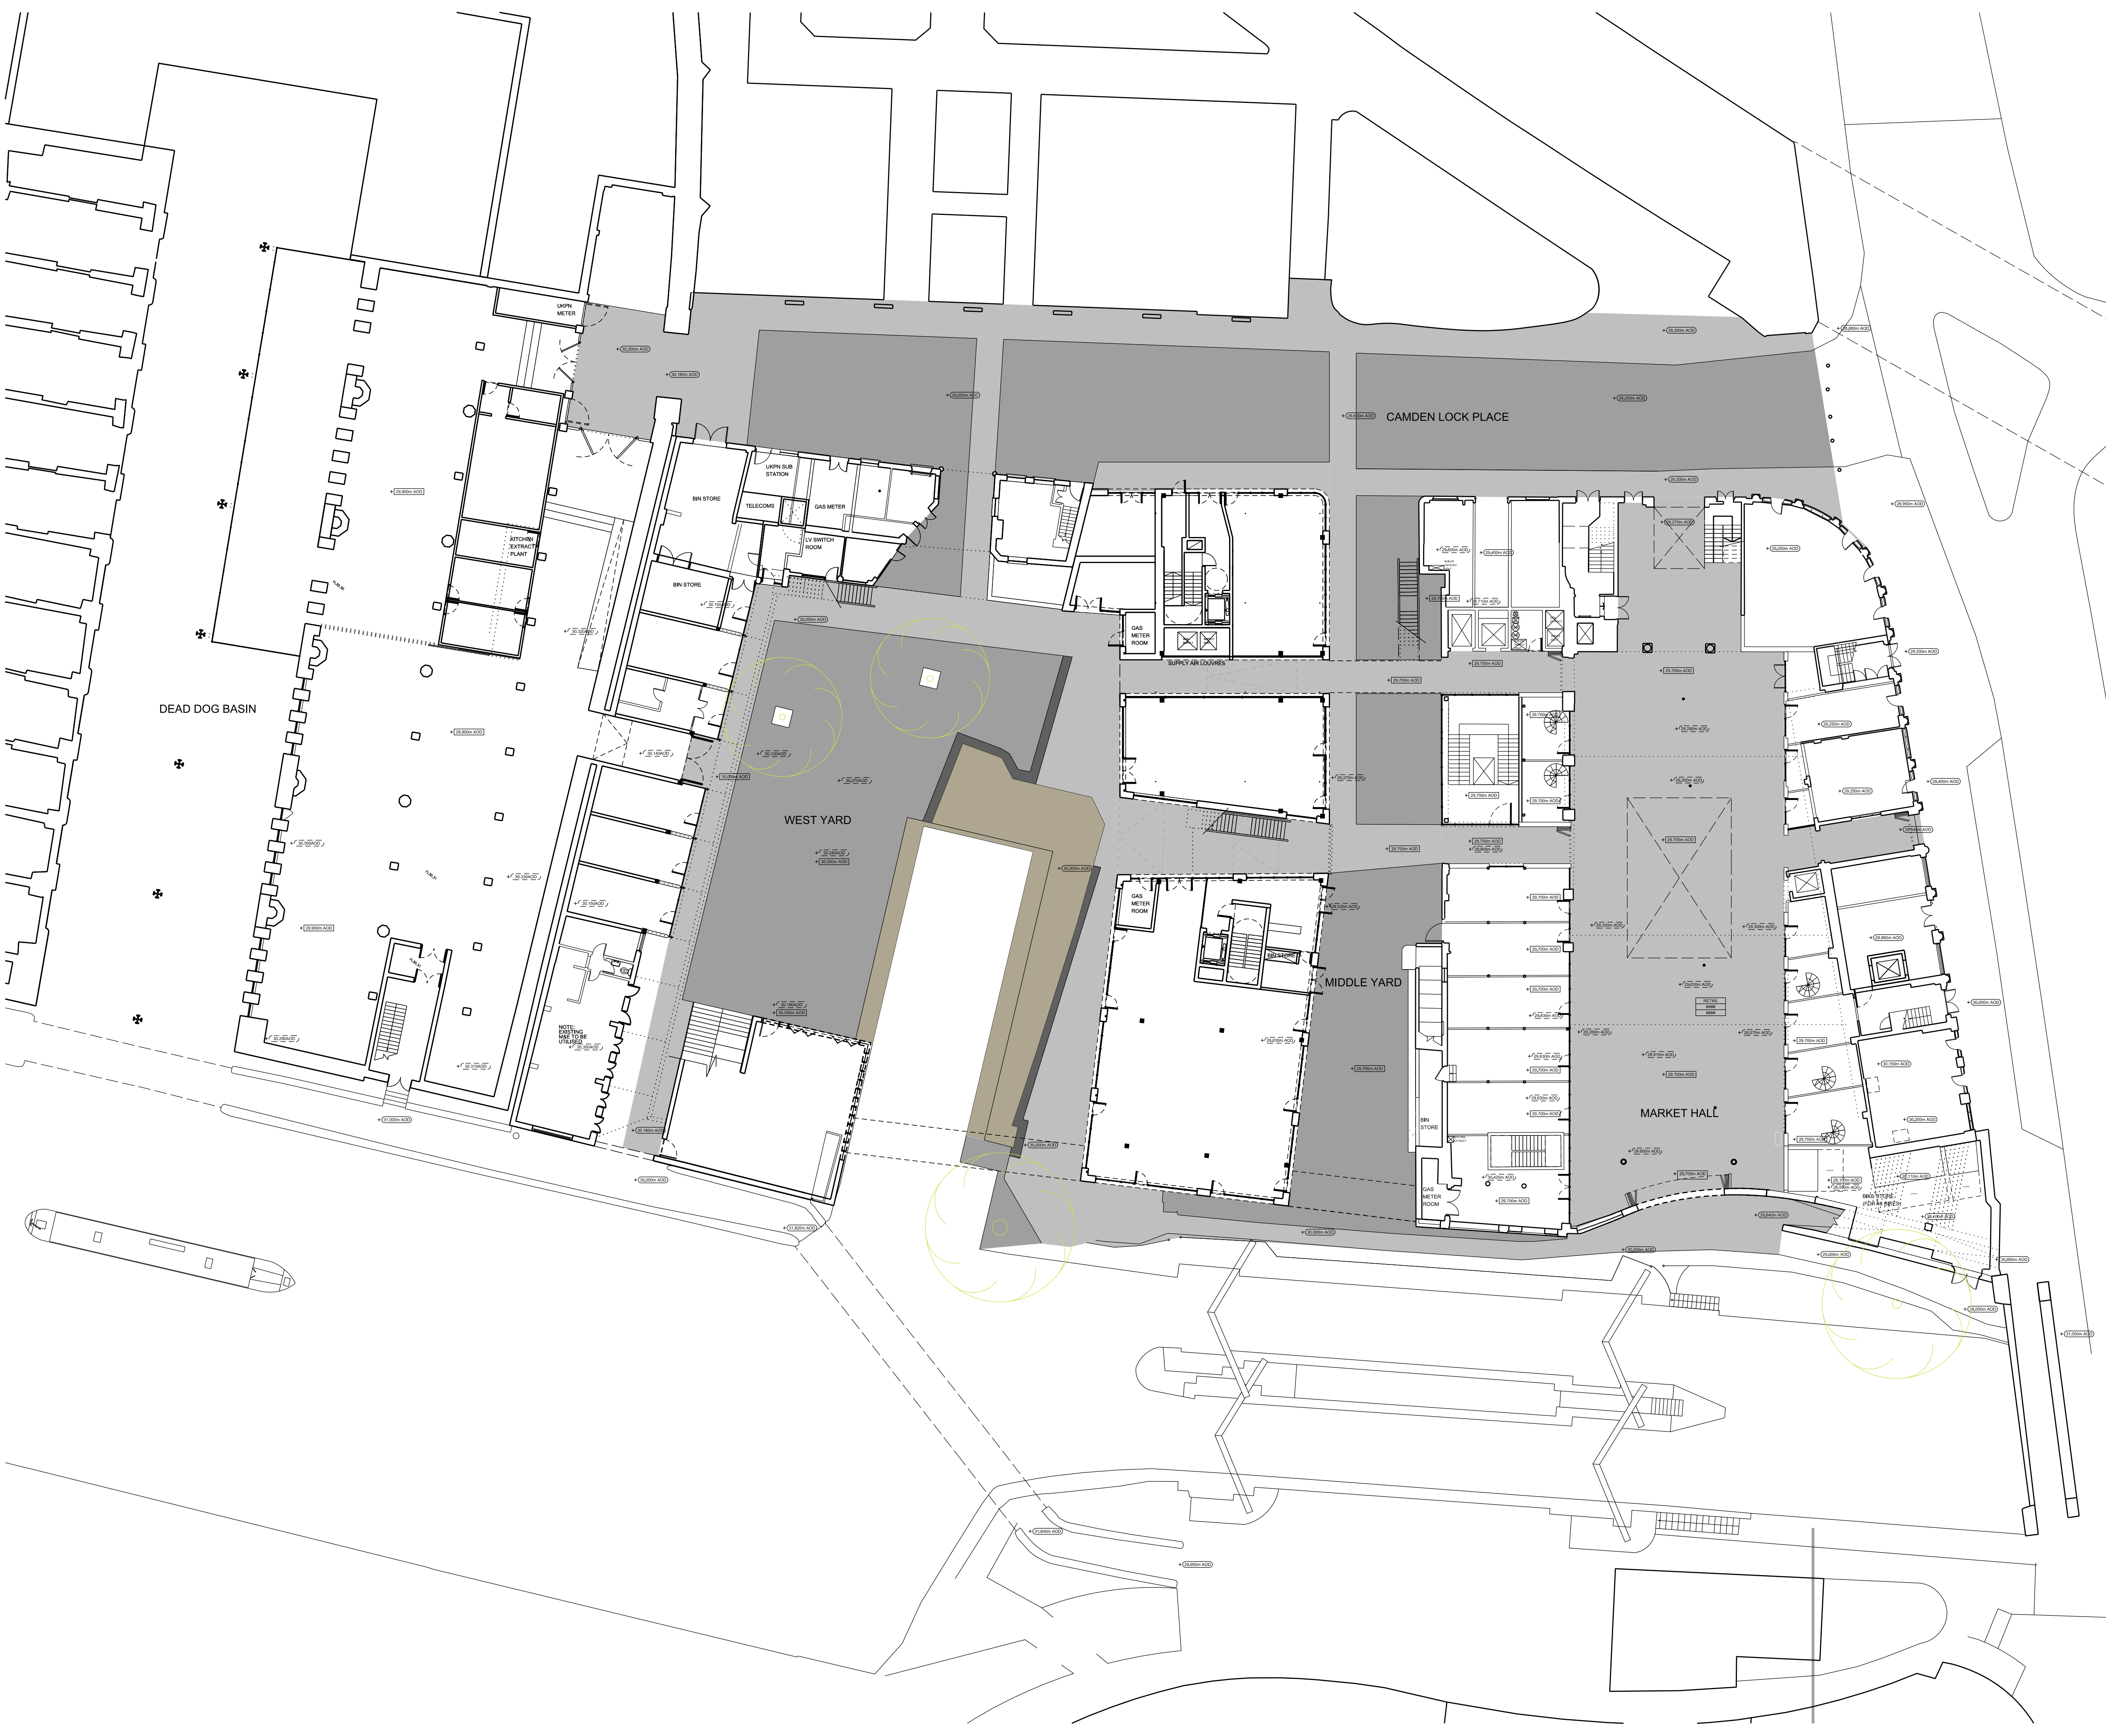
- Granite setts retained, refurbished and relaid
- Granite strips (accessible route)
- Existing basin stones retained
- Wooden Decking (existing retained)

The proposed hard landscaping drawings numbered 13483 A L00 P91 000 and 100 by Piercy&Company entail that hard surfacing will involve a mixture of retaining existing surfacing, refurbishing and relaying existing hard surfacing and new replacement hard surfacing. Traditional methods of construction (e.g. requiring excavation) within RPAs would result in unacceptable root severance and compaction of the soil leading to the death of roots as access to air and water is restricted. This could lead to the decline and ultimately the death of affected trees.

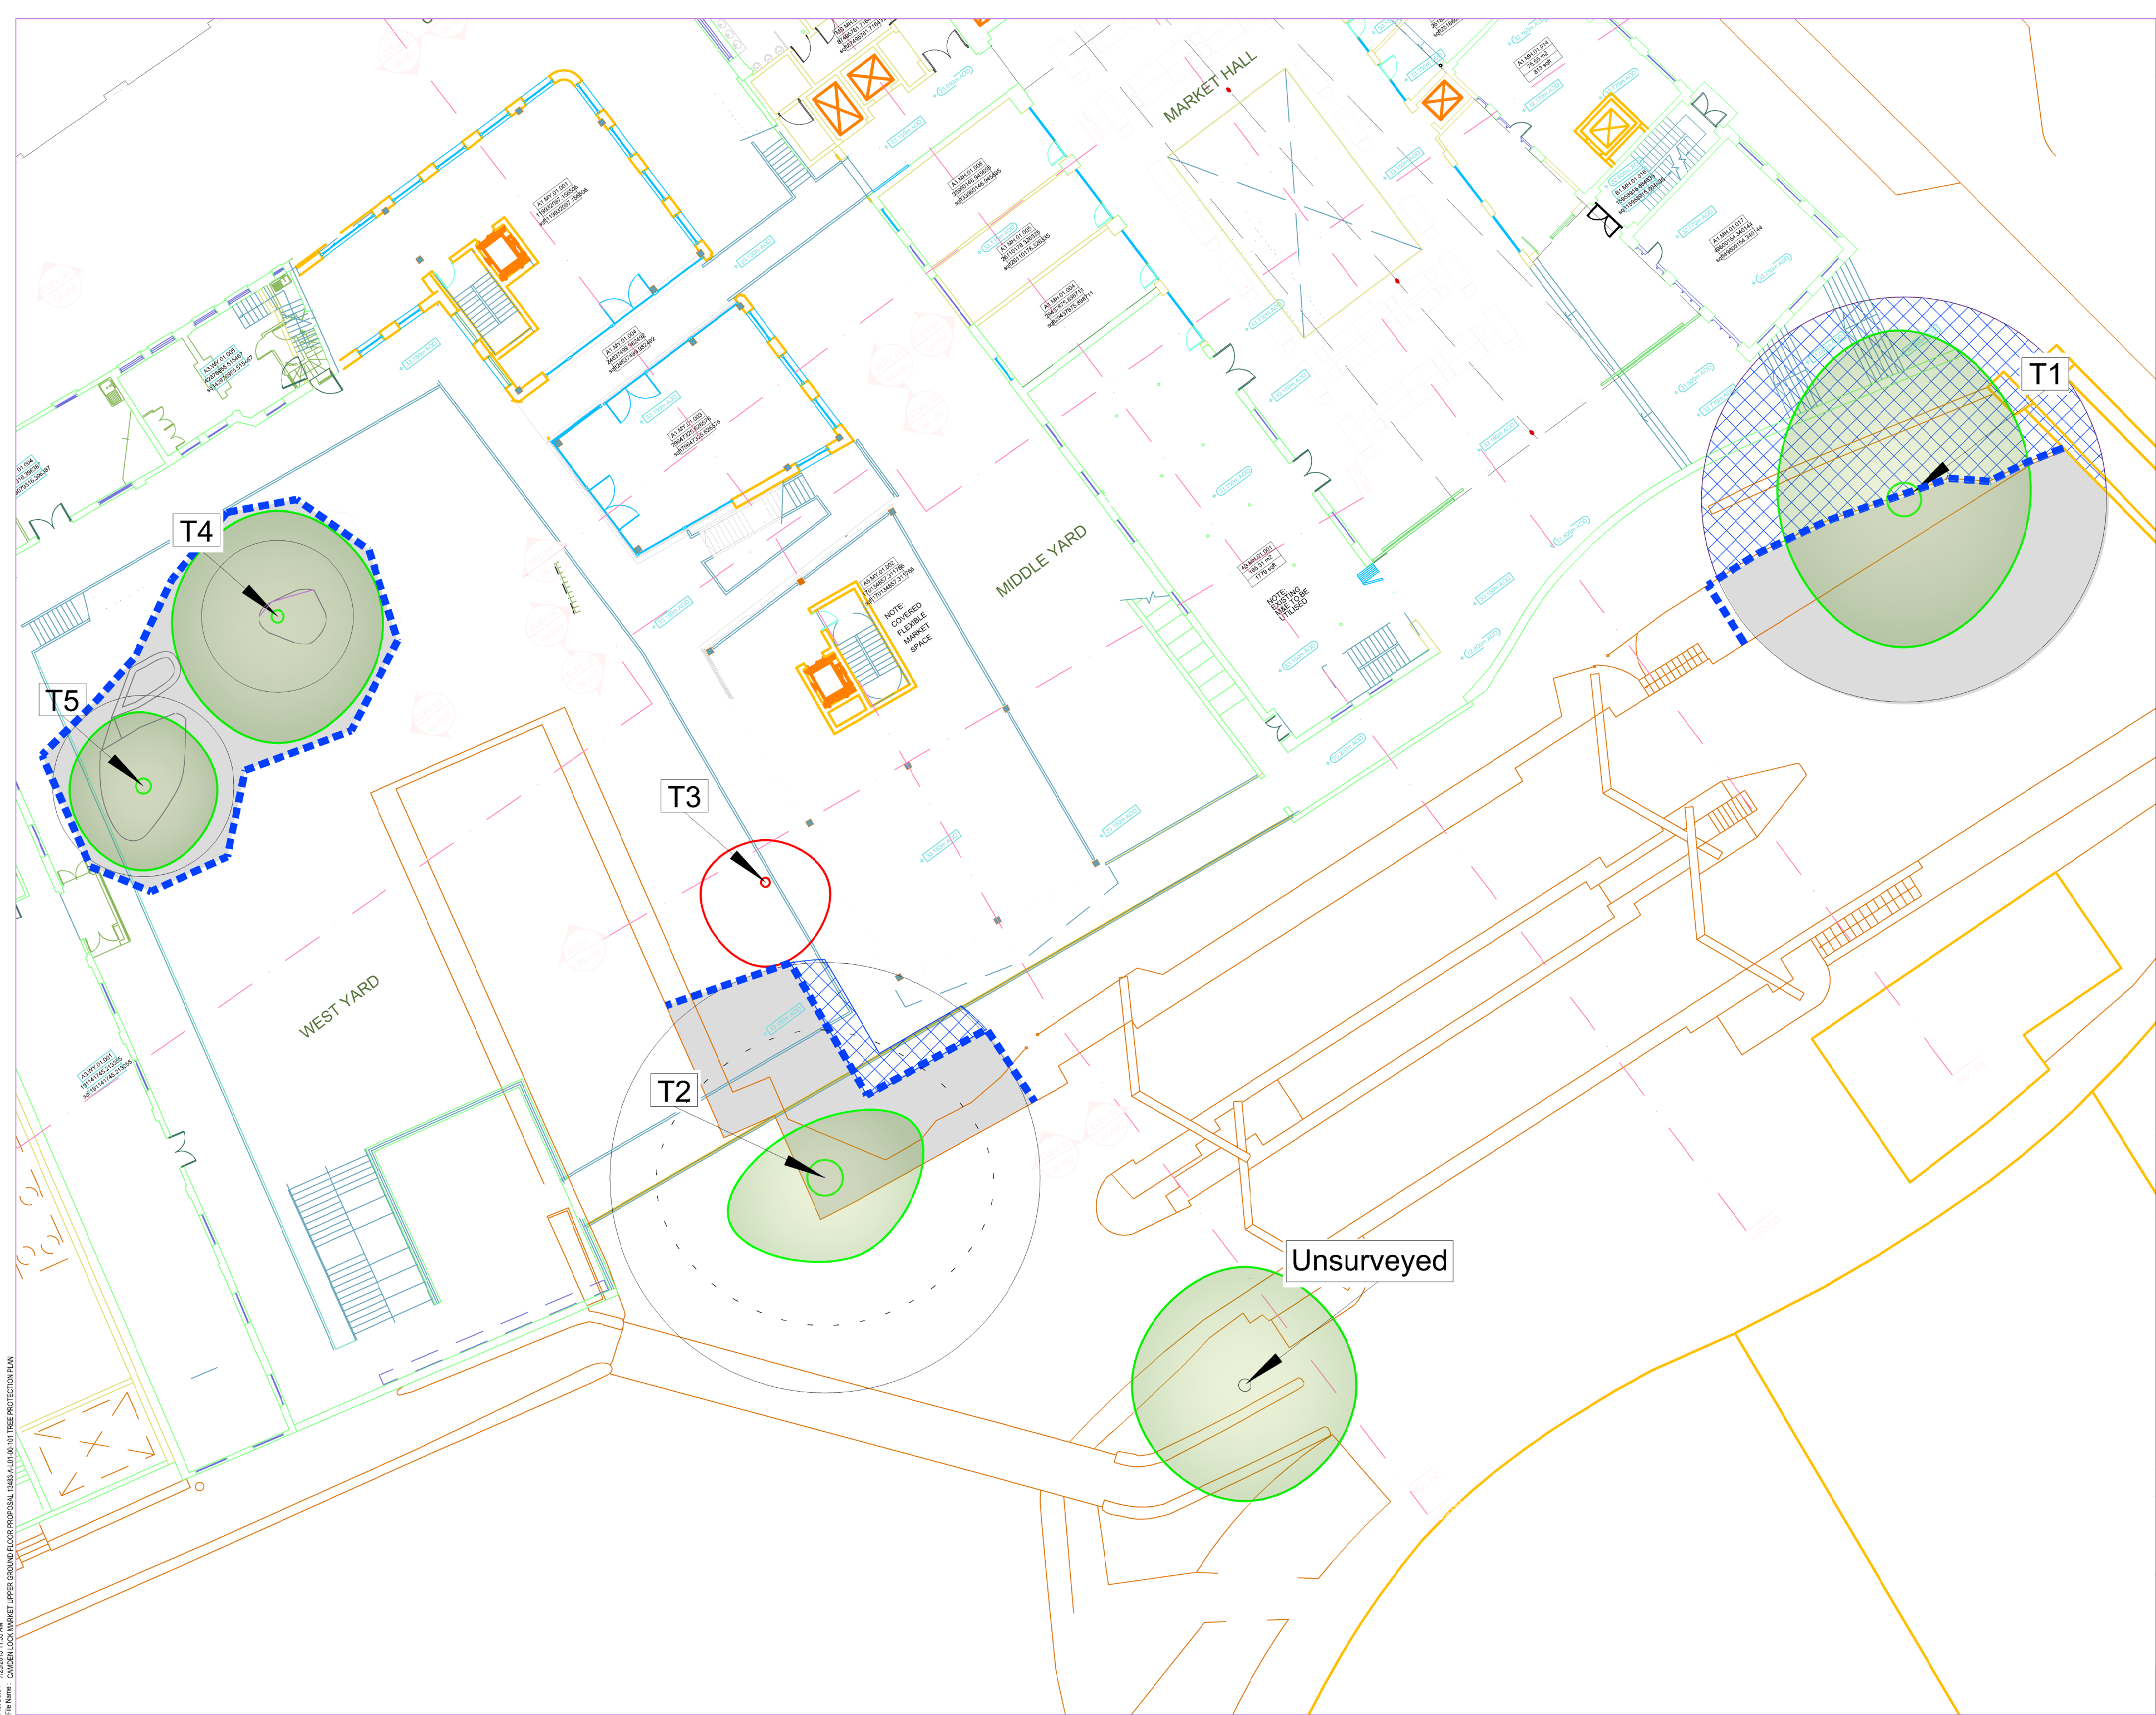
- TPP-01 – Tree Protection Plan

Plot Date: 7/23/2015 11:35 AM
File Name: CAMDEN LOCK MARKET UPPER GROUND FLOOR PROPOSAL 1348-A-L01-00-101 TREE PROTECTION PLAN
